Sites under threat.

Tell settlements from South-East Romania

Katia MOLDOVEANU*
Radian-Romus ANDREESCU*

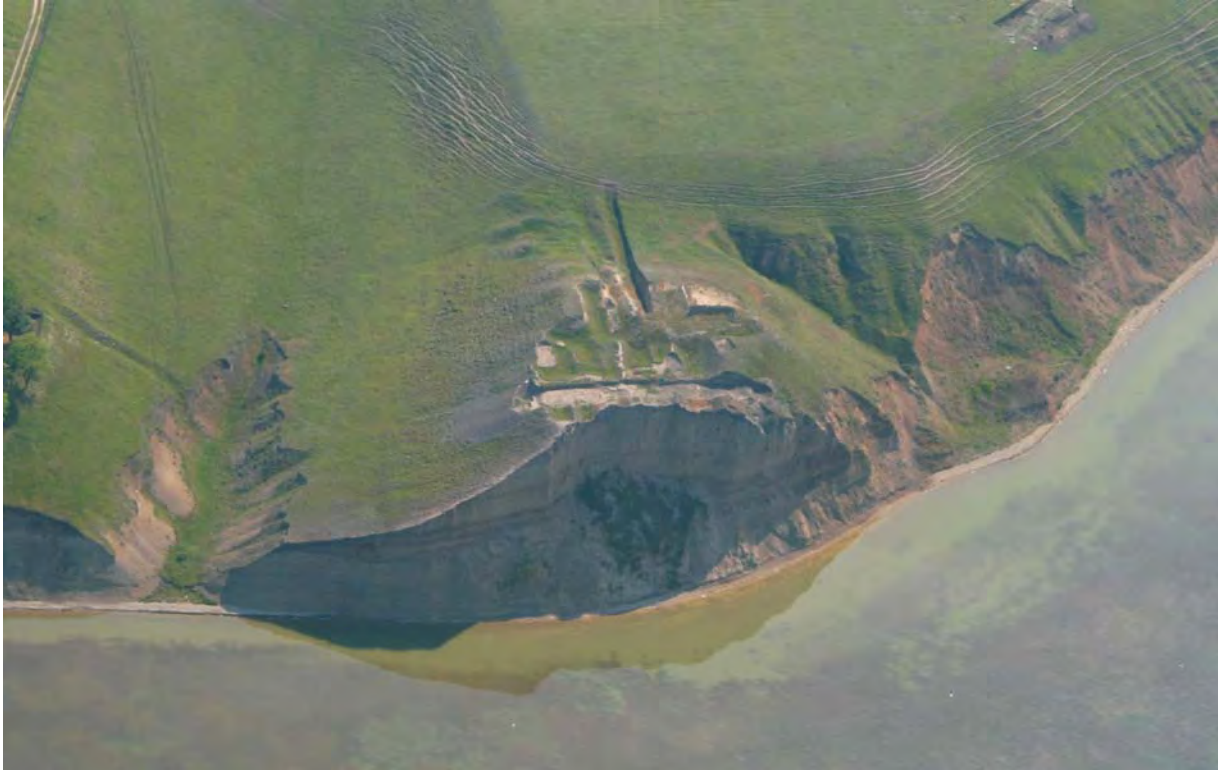
1

Pl. 1. Sultana Malu-Roșu, Călărași County. 1. Aerial image of the site (photo C. Bem, © cIMeC); 2. North-western view of the site eroded by the waters of Iezerul Mostiștea.

Sultana - *Malu Roșu* (pl. 1/1-2). The *tell* settlement is placed on the high terrace of Lake Iezerul Mostiștei, in Sultana village, Mănăstirea commune, Călărași County. The oldest scientific researches in a *tell* type settlement were undertaken at Sultana site, which is related with the beginning of the Romanian school of archaeology. Rescue excavations were undertaken at the site in the 70 – 80's of the last century. The excavations were restarted in 2001 (R. Andreescu, C. Lazăr 2008).

Nowadays what was left of the settlement measures cca. 35-40 m on the long axis and 25-30 m on the short axis. To make an idea about how the site was destroyed in the last decades, just notice that in 1923 archaeologist I. Andrieșescu estimated the long axis of the settlement at about 71 m (I. Andrieșescu 1926, p. 172). The area corresponding to about 30-35 m of the long axis of the settlement collapsed in the waters of the lake in approximately 80 years. Since 2001 when researched were restarted, more than 5m from the north-western edge of the settlement were collapsed. A very rich archaeological inventory was discovered at the site. Among it stands out a little treasure containing golden objects, some of the oldest artifacts in gold found in Europe. Nevertheless the site is not on the *List of Historical Monuments*¹ of Călărași County. This situation is due to a problem related to the legal status of the field on which the site is located.

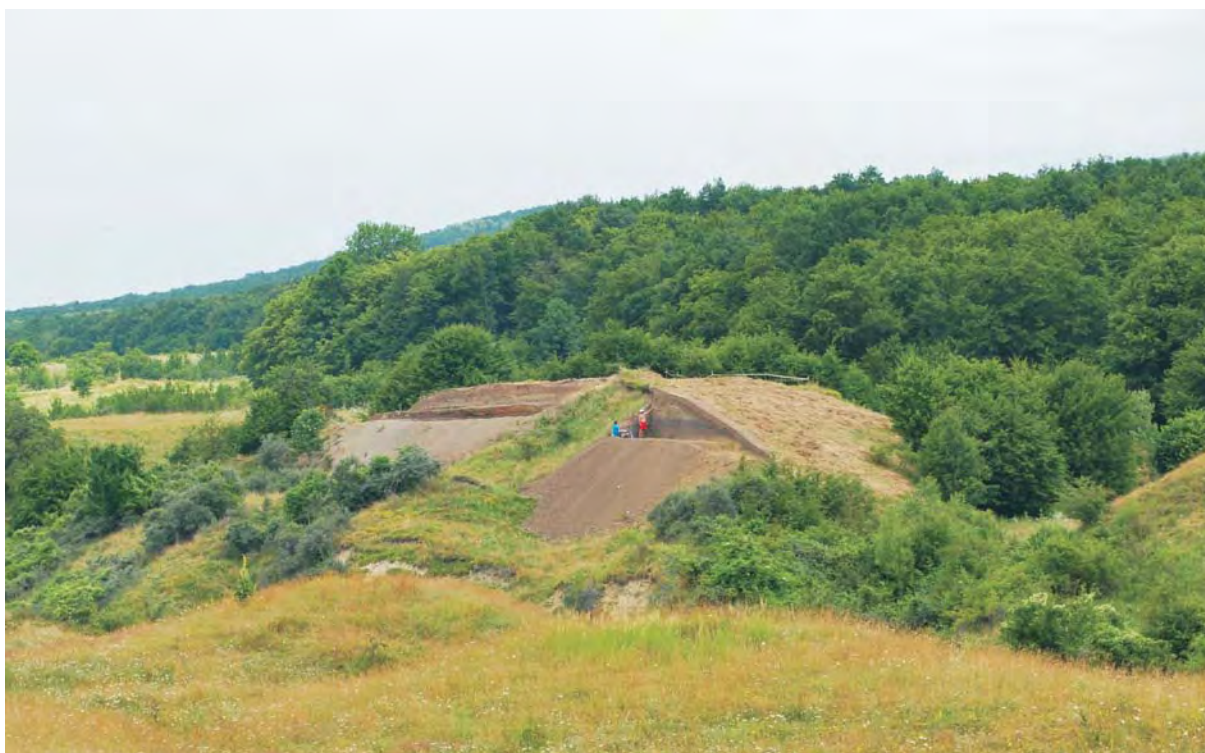
1

Pl. 2. 1. Coțatcu Cetățuia, Buzău County. General view of the site affected by land slides; 2. Glina, Ilfov County. Image of the site used as earth source for different constructions.

Coțatcu *Cețățuia* (pl. 2/1). The *tell* settlement is placed in the bottom of a valley near Coțatcu village, Podgoria commune, Buzău County. The site was submitted to an accelerated deterioration in the last decades. The site was discovered in 1971 when the first land slides occurred and they affected the site. The researches undertaken back then consisted in a 40 x 1,5 m sondage on the long axis of the settlement. When the excavations were restarted in 2006 there were only 10-12 m left of this long sondage, the rest being collapsed in the nearby valley (R. Andreescu *et alii* 2010). In the settlement profile there were visible traces of burnt dwellings. The rich archaeological inventory belongs to the so called Stoicani-Aldeni cultural group dated back in the 5th millennium BC. Stoicani-Aldeni is a cultural group located in the contact area between the Chalcolithic civilisations of Precucuteni-Cucuteni and Gumelnița.

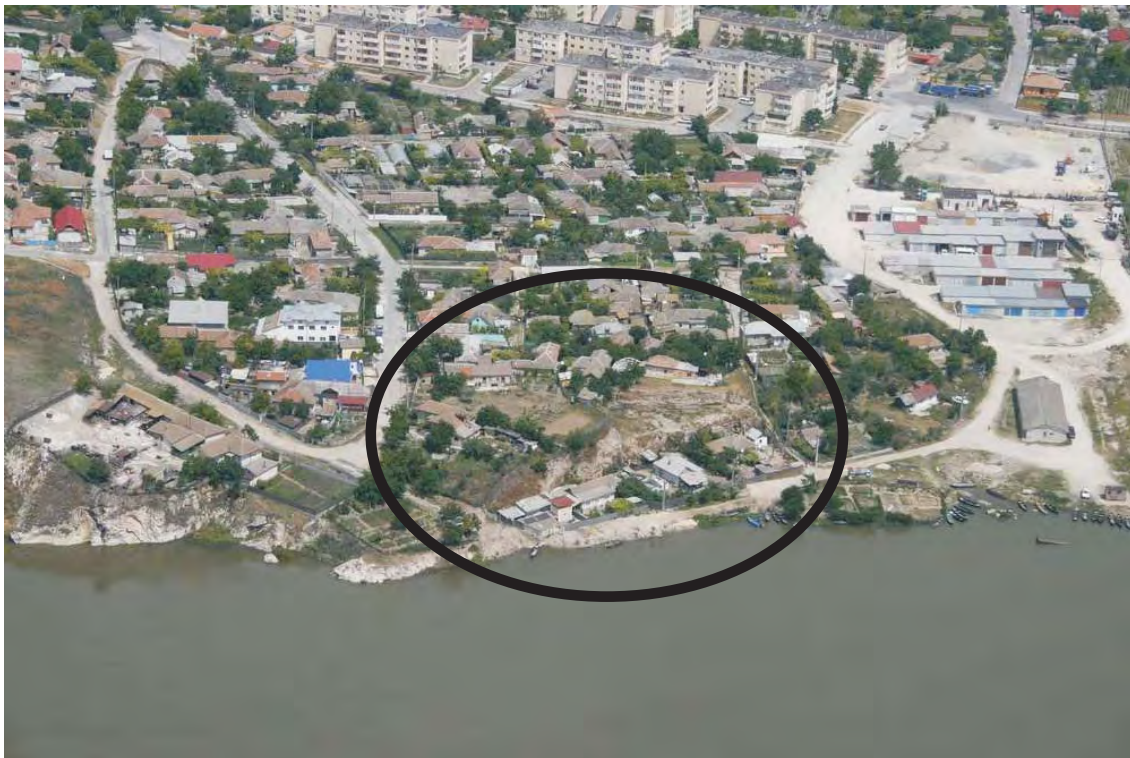
1

Pl. 3. Hârșova, Constanța County. 1. Aerial view of the site invaded by modern habitation (photo C. Bem, © cIMeC); 2. View of the profile with traces of burnt Chalcolithic dwellings.
Hârșova, jud. Constanța. 1. Imagine aeriană a sitului invadat de locuirea modernă (foto C. Bem, © cIMeC). 2. Vedere a profilului cu urme de locuințe eneolitice incendiate.

Hârșova (pl. 3/1-2). The *tell* type settlement is placed on the Danube shore, in Hârșova town, Constanța County. The site is the biggest *tell* settlement in Romania, with an impressive height of 12 m, formed by the successive deposition of settlements belonging to the cultures Boian, Gumelnița and Cernavodă I, dated back to the 5th – 4th mill. BC. Initially the site covered more than two hectares but due to the erosion caused by Danube River and to human activities, the remaining settlements measures nowadays 190 m on the long axis and 80 m on the short axis. Modern houses could be found on almost the entire surface of the *tell* settlement and around it, so that the last habitation levels of the *tell* settlement were affected. The archaeological researches could be undertaken, with exceptional results, only a small part of the site (D. Popovici *et alii* 2000). The *tell* settlement from Hârșova is an unhappy example of conjugation of destructive natural factors and human made activities. The site is on the *List of Historical Monuments* (code CT-I-s-A-02677).

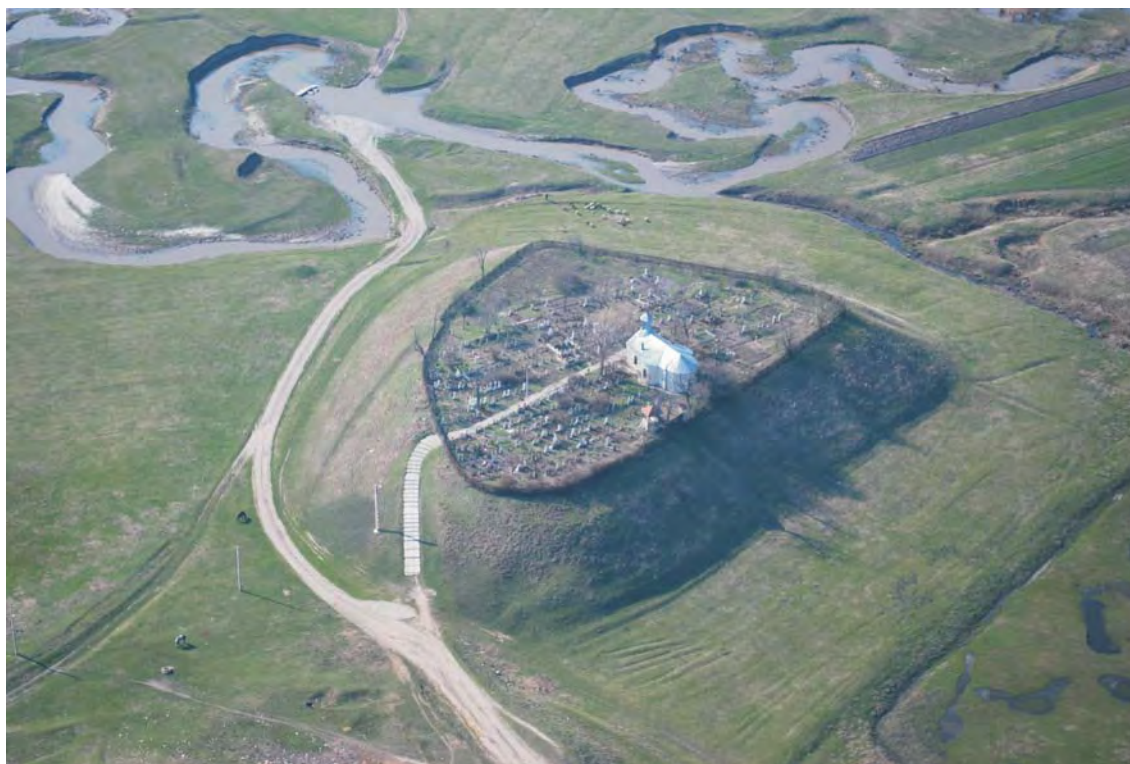
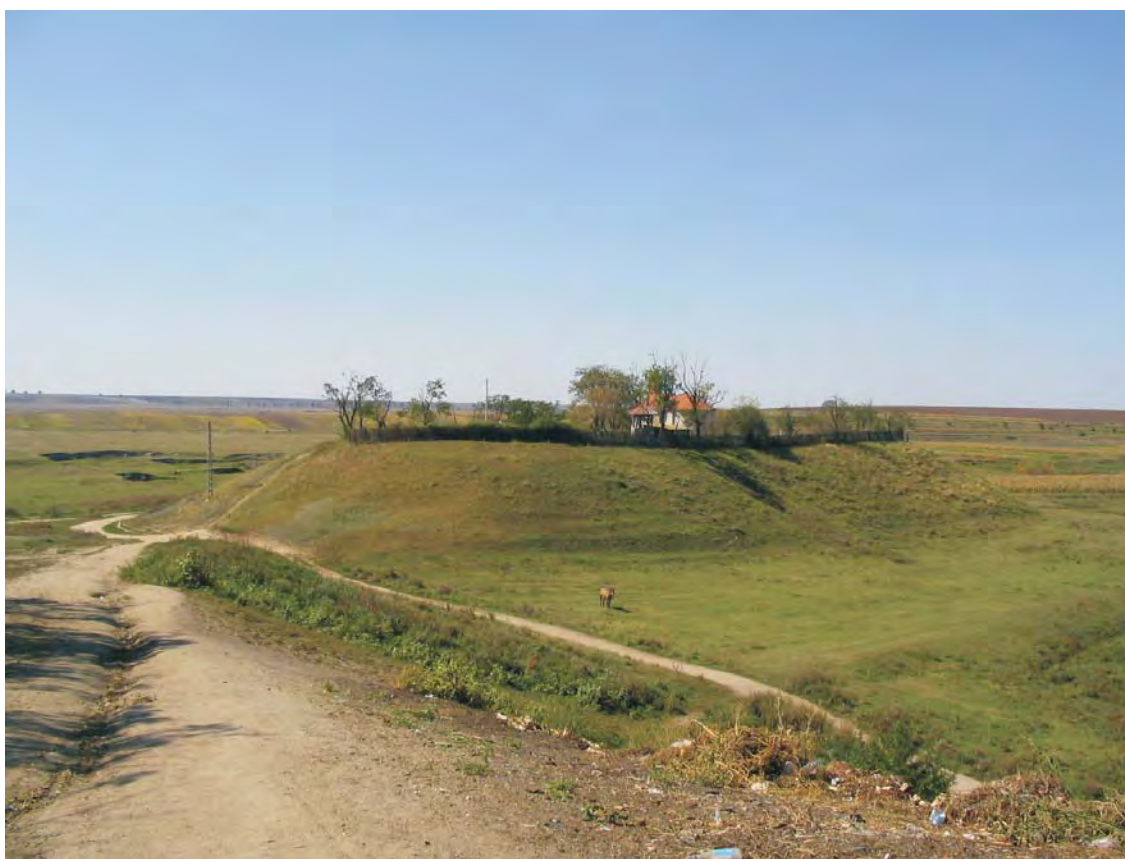
Pl. 4. Măgura Bran, Teleorman County. 1. Aerial view of the site with the village cemetery (photo C. Bem, © cIMeC); 2. View of the site from the village.
Măgura Bran, jud. Teleorman. 1. Imagine aeriană a sitului cu cimitirul satului (foto C. Bem, © cIMeC); 2. Vedere a sitului dinspre sat.

Măgura-Bran (pl. 4/1-2). The *tell* settlement is placed on a remnant in Clănița valley, at the edge of Măgura commune, Teleorman County. Its present dimensions are 90 m on the long axis and a maximum length of 60 m. Its height is about 11 m, from which only 6,5 m are traces of successive settlements from Iron Age, Bronze Age and Eneolithic (Gumelnița culture). The *tell* settlement surface is occupied by the church and cemetery of Bran Village, though the upper levels of prehistoric habitations were strongly damaged. Under these circumstances, only a small sondage could be done

on the slope in order to establish the site stratigraphy (R. Andreescu, K. Moldoveanu 2010, p. 17-18). The site is on the *List of Historical Monuments* (code TR-I-s-B-14210.02).

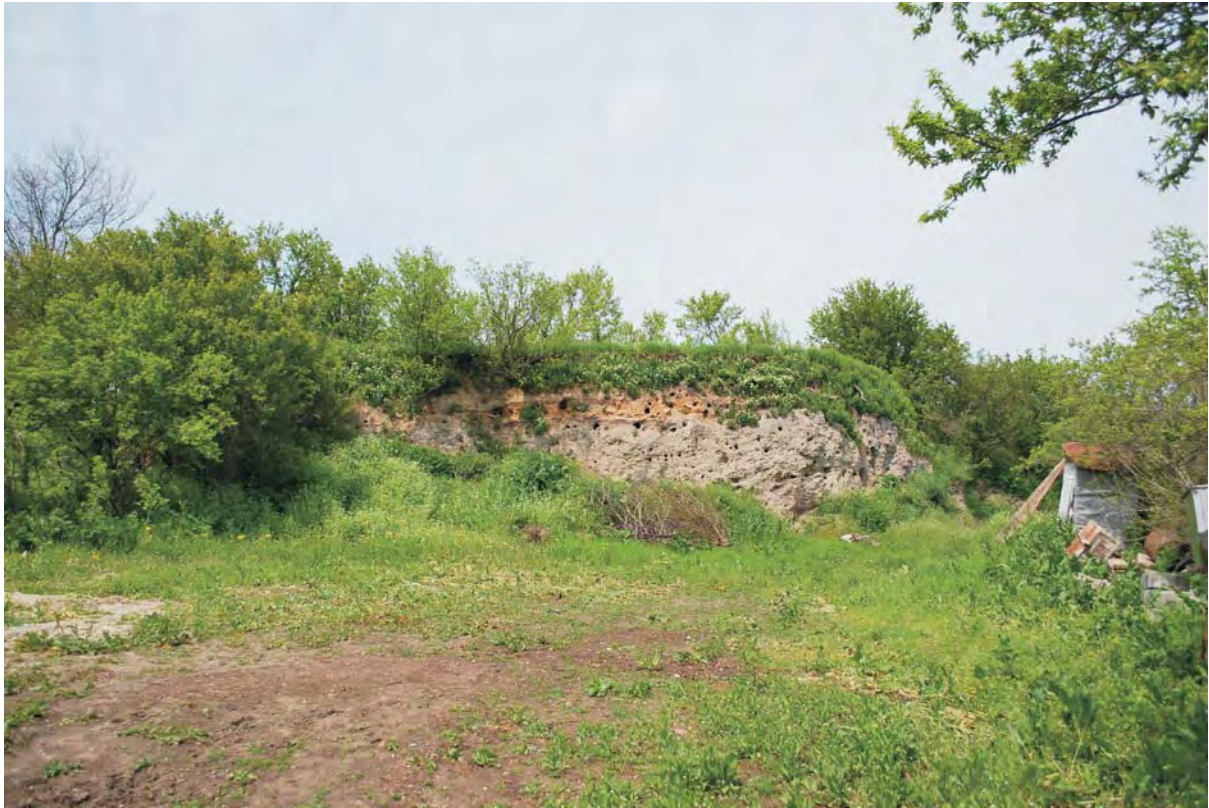
1

Pl. 5. Uzun, Giurgiu County. 1. Profile of the site with traces of Neolithic burnt dwellings; 2. View of the site invaded by constructions.

Uzunu (pl. 5/1-2). The *tell* settlement is placed in the nearby of Călniștea valley, in Uzunu village, Giurgiu County. The site is placed at the edges of the village and it was affected by the actions of the villagers. Archaeologist D. Berciu mentioned in 1956 a mound of big size located in the courtyards of two villagers, who repetitively made diggings on the southern edge of the settlement in order to enlarge the courtyard and obtain earth for other constructions (D. Berciu 1956, p. 500-501). Nowadays the site is much destroyed by the villagers who extended their courtyards in the detriment of the *tell* settlements. In the spring of 2010 many burnt dwellings could still be observed in the site profile and its very vicinity a new house was under construction. Nevertheless, the site is on the *List of Historical Monuments* (code GR-I-s-B-14834).

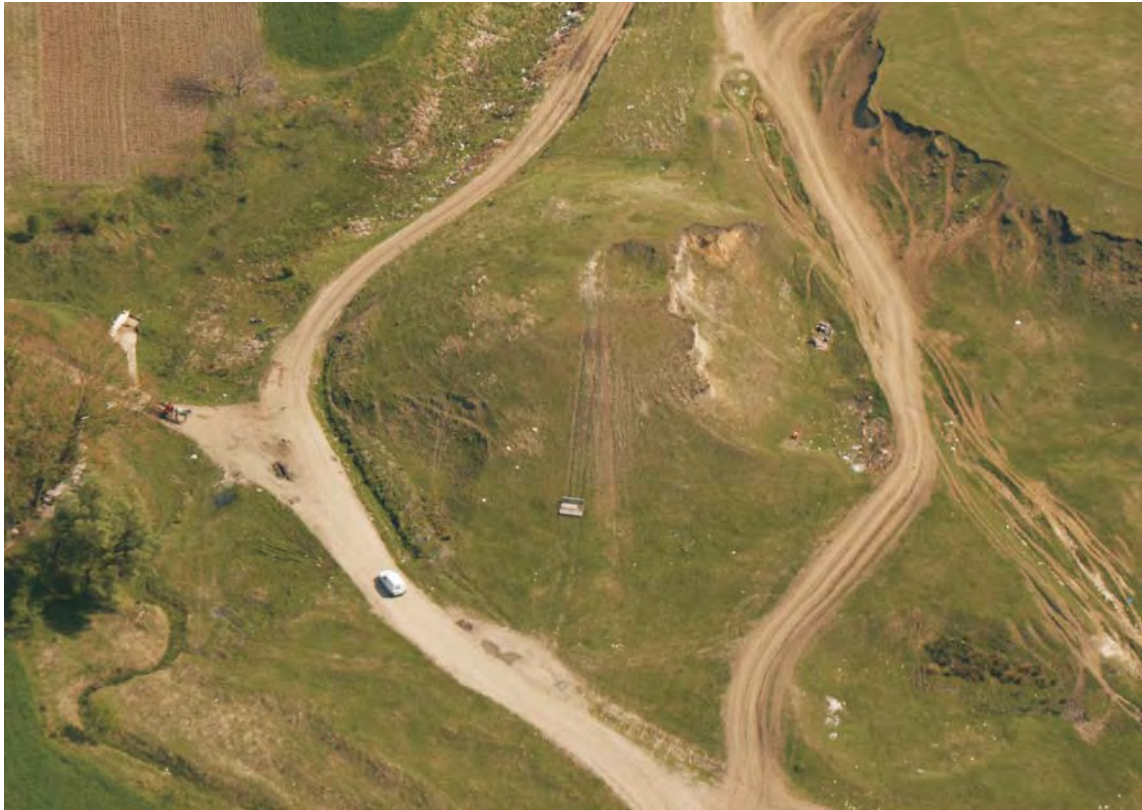
1

Pl. 6. Alexandria Gorgan, Teleorman County. 1. Aerial view of the site (photo C. Bem, © cIMeC);
2. Stratigraphic profile during researches.
Alexandria Gorgan, jud. Teleorman. 1. Imagine aeriană a sitului (foto C. Bem, © cIMeC). 2. Profil
al sitului în timpul cercetărilor.

Another example is the site named *Gorgan* (pl. 6/1-3), Teleorman County, placed on Veda River near the town of Alexandria. It is one of the oldest mention of a *tell* settlements in Teleorman County by archaeologist C. Bolliac during his "archaeological exploration" from 1869 (C. Bolliac 1869, p. 3-4). Since that time, C. Bolliac mentioned a hole made by treasure hunters in the middle of the settlement. A side of the site was also destroyed by a local road. The settlement was researched in 2002 when a stratigraphical profile was made by cutting the side destroyed by the local road (R. Andreescu, D.W. Bailey 2003). Many trees could be found on site in past times and they also contributed to the partial destruction of the last habitation levels. The site is on the *List of Historical Monuments* (code TR-I-s-B-14182).

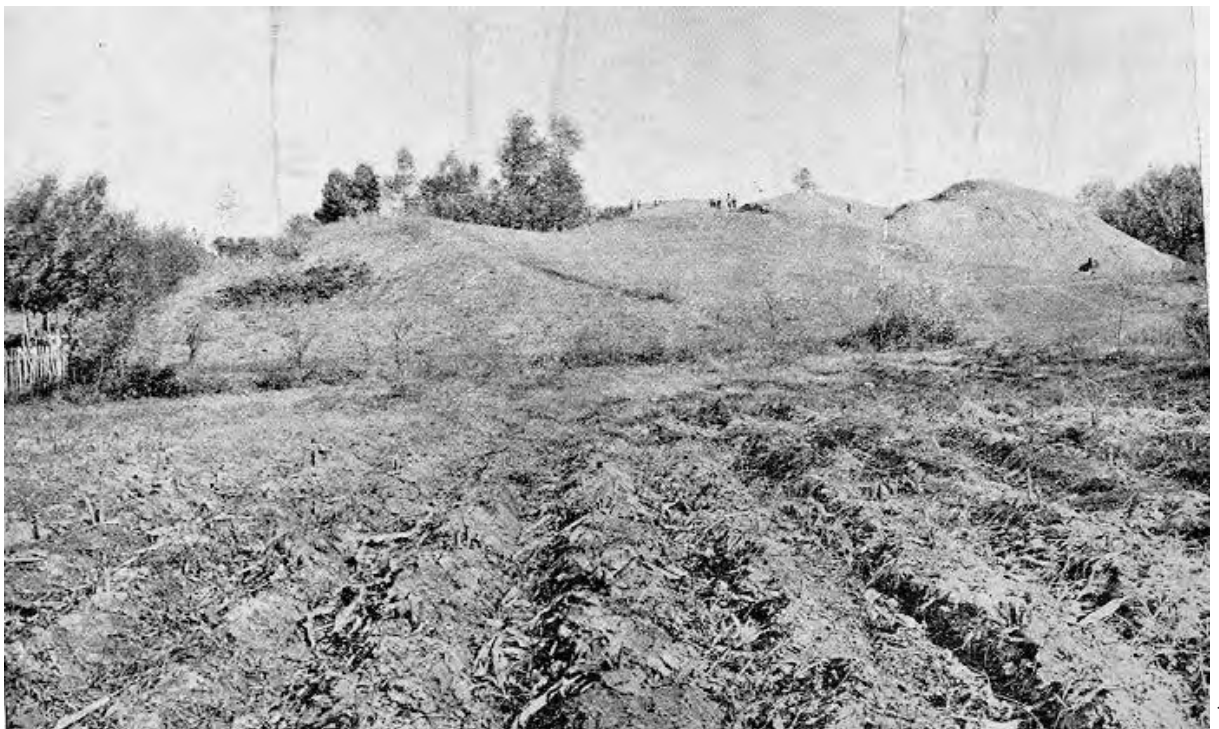
1

Pl. 7. Vidra Măgura Jidovilor, Ilfov County. 1. Image of the site during 1933 campaign (after D.V. Rosetti, 1934); 2. Image of the place where the site used to be, nowadays completely destroyed by agricultural works; 3. "The Goddess from Vidra", anthropomorphic figurine discovered in the settlement (after D.V. Rosetti, 1934, pl. I-III/1).

One significant example of intentional destruction of a site happened in the case of *tell* settlement from Vidra *Măgura Jidovilor* (pl. 7/1-3), Ilfov County, placed in Sabar River valley near Bucharest. The site was researched by archaeologist D.V. Rosetti in the interwar period (D.V. Rosetti 1934, p. 7). He mentioned that the *tell* settlement had a height of 6 m, composed of habitations levels belonging to Boian and Gumelnița cultures (6th – 5th mill. BC).

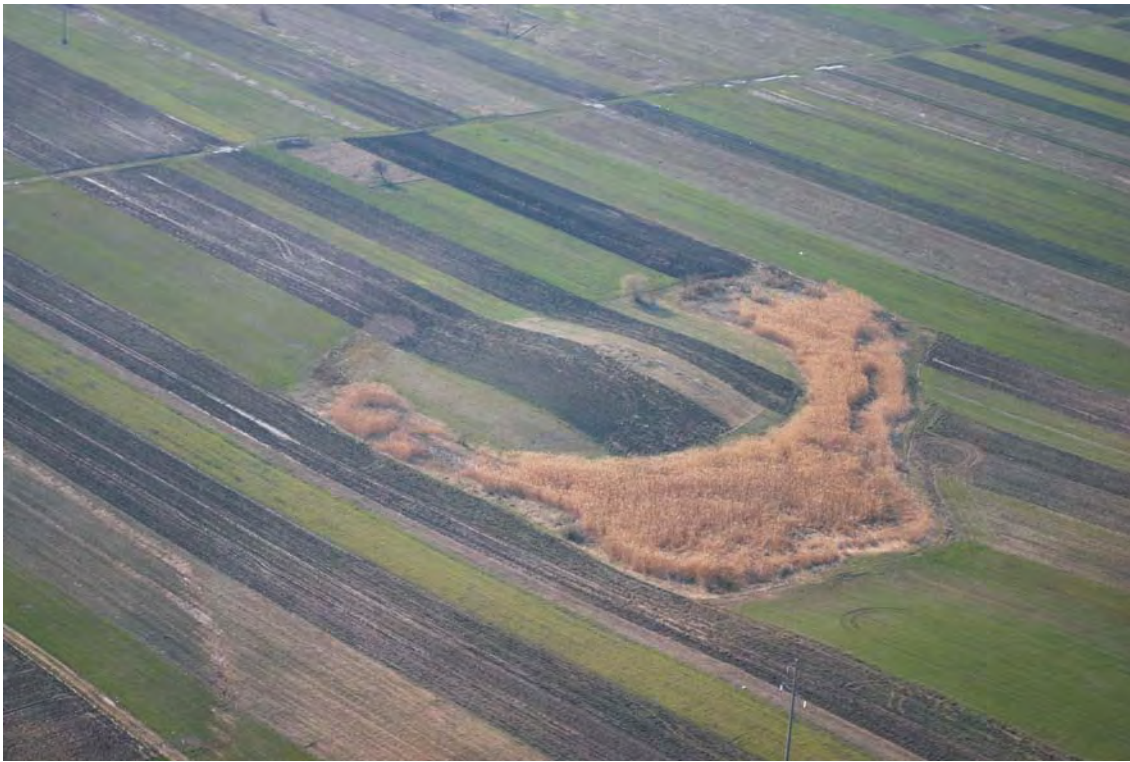
1

Pl. 8. Sites affected by agricultural works: 1. Slăvești, Teleorman County; 2. Trivale Moșteni, Teleorman County (photo C. Bem, © cIMeC).
Situri afectate de lucrări agricole: 1. Slăvești, jud. Teleorman; 2. Trivale Moșteni, jud. Teleorman (photo C. Bem, © cIMeC).

Such examples could also be found on Teleorman valley, at Slăvești (pl. 8/1) – the site is on the *List of Historical Monuments* (code TR-I-m-B-14224.01) or Trivale-Moșteni (pl. 8/2) – the site is on the *List of Historical Monuments* (code TR-I-m-B-14227.02). As a result of agricultural works, the edges of the site was compromised. Another example is the *tell* settlement from Petru Rareș, Giurgiu County. The site was researched by archaeologist D. Berciu (D. Berciu 1937) and nowadays it is used as agricultural field. The site is not on the *List of Historical Monuments*.

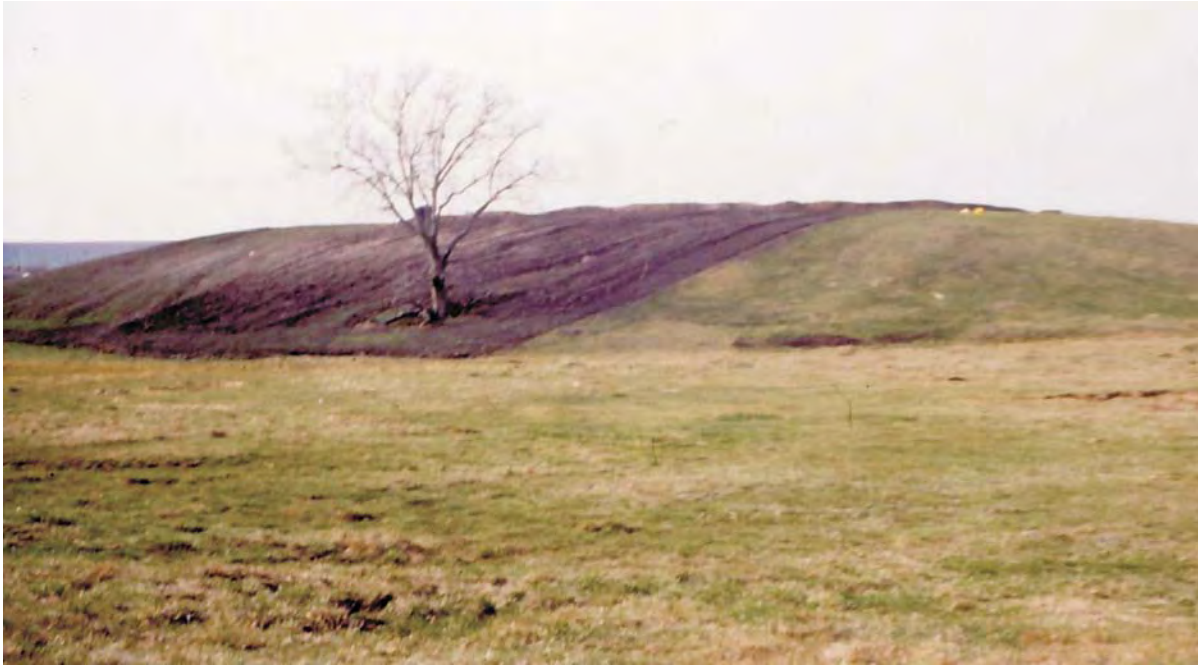
1

Pl. 9. Vitănești Măgurice, Teleorman County: 1. Image from 1993 with the site affected by agricultural works; 2. Aerial view of the site from 2010 (photo C. Bem, © cIMeC).
Vitănești Măgurice, jud. Teleorman: 1. Imagine din anul 1993 cu situl afectat de lucrări agricole; 2. Imagine aeriană a sitului din anul 2010 (foto C. Bem, © cIMeC).

There are more examples but we focused on the *tell* settlement from Vitănești - *Măgurice* (pl. 9/1-2), Teleorman County, which is a special case. The researches undertaken here starting with the year 1993 showed the destruction degree on which the site was submitted by man made actions (R. Andreescu *et alii* 2003). The *tell* settlement is placed in Teleorman River valley, in the vicinity of the houses from Vitănești village. After 1989 the land on which the site is located was given back to the owners who transformed it into an agricultural field, which determined the intervention of archaeologists. As a consequence, agricultural works stopped in 1995 and the site was introduced in the *List of Historical of Monuments*. The archaeological investigations revealed that the last habitation level, belonging to Gumelnița culture, placed 20-30 cm under the ground, was strongly disturbed by agricultural works. Thus the burnt dwellings belonging to this level were partially destroyed and spread on the surface of the site. Many other holes dug by the local villagers also contributed to the site degradation. Another element which seriously perturbed the site stratigraphy is represented by animals which dug large galleries through the *tell* settlement, leading to the destruction of the site, mainly the prehistoric dwellings. The site is on the *List of Historical Monuments* (code TR-I-s-A-14230).

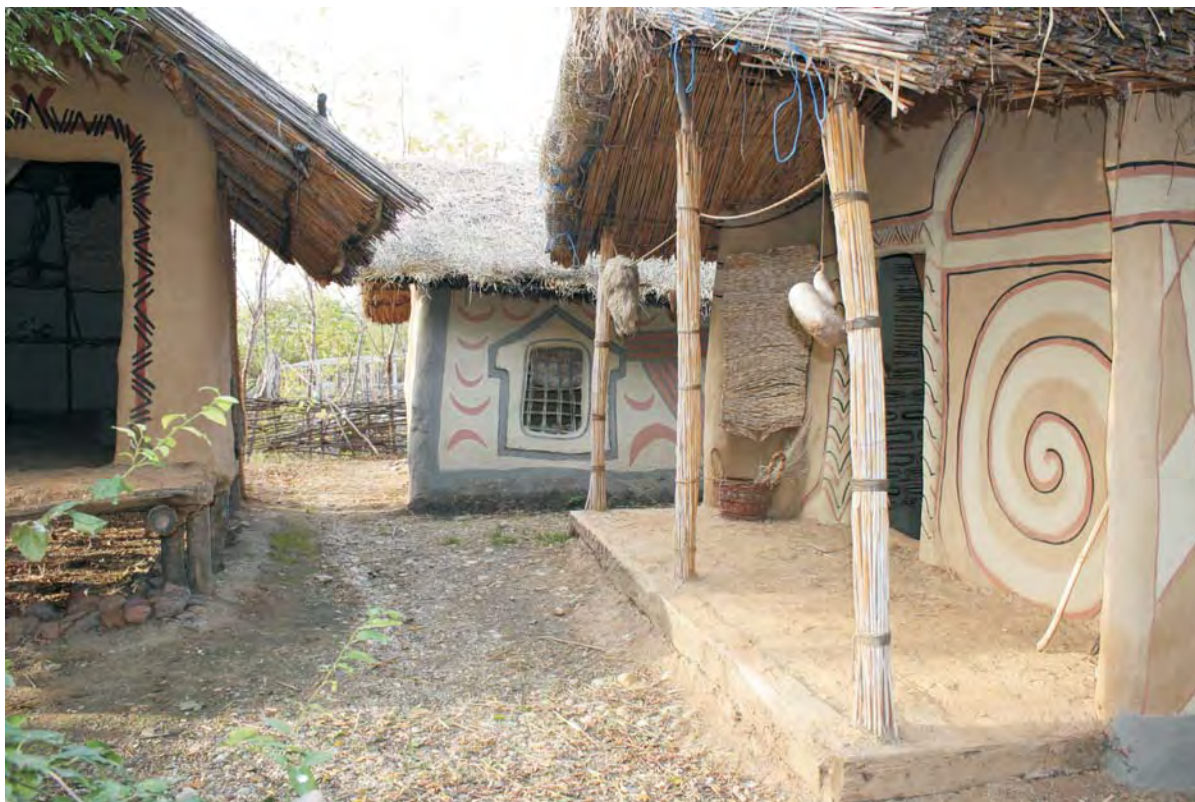
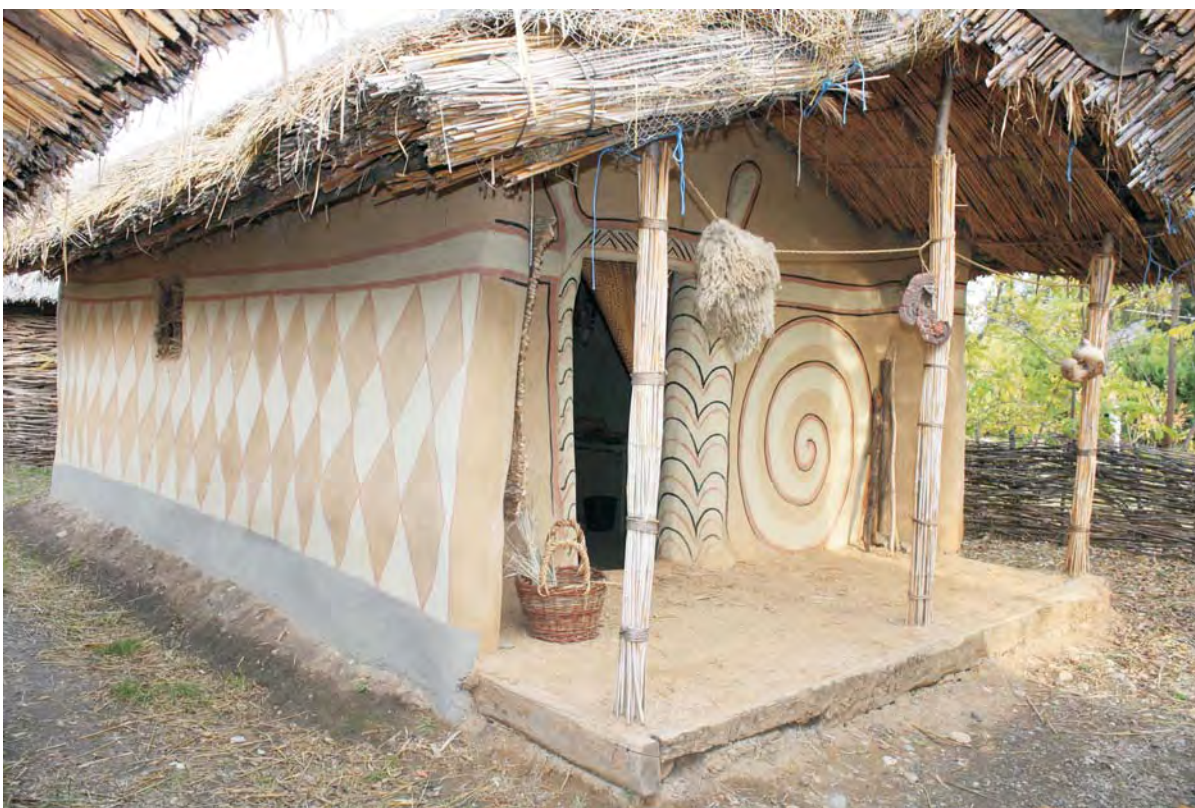
Pl. 10. Drăgănești-Olt, Olt County. 1-2. Reconstruction of the tell settlement within the Museum of Boian Plain.
Drăgănești-Olt, jud. Olt. 1-2. Reconstituirea așezării de tip tell în cadrul Muzeului Câmpiei Boianului.

An interesting case is the one found at Drăgănești-Olt (pl. 10/1-2), where there is a *tell* settlement which was partially destroyed by an industrial railway and currently serves as a waste disposal area. In exchange, the results of the researches undertaken in this site (M. Nica *et alii* 1994) are visible in the local museum (Museum of Boian Plain) where there is a very interesting ethno-archaeological park with a reconstruction of the *tell* settlement at 1:1 scale. There is also a site museum at Drăgănești-Olt.

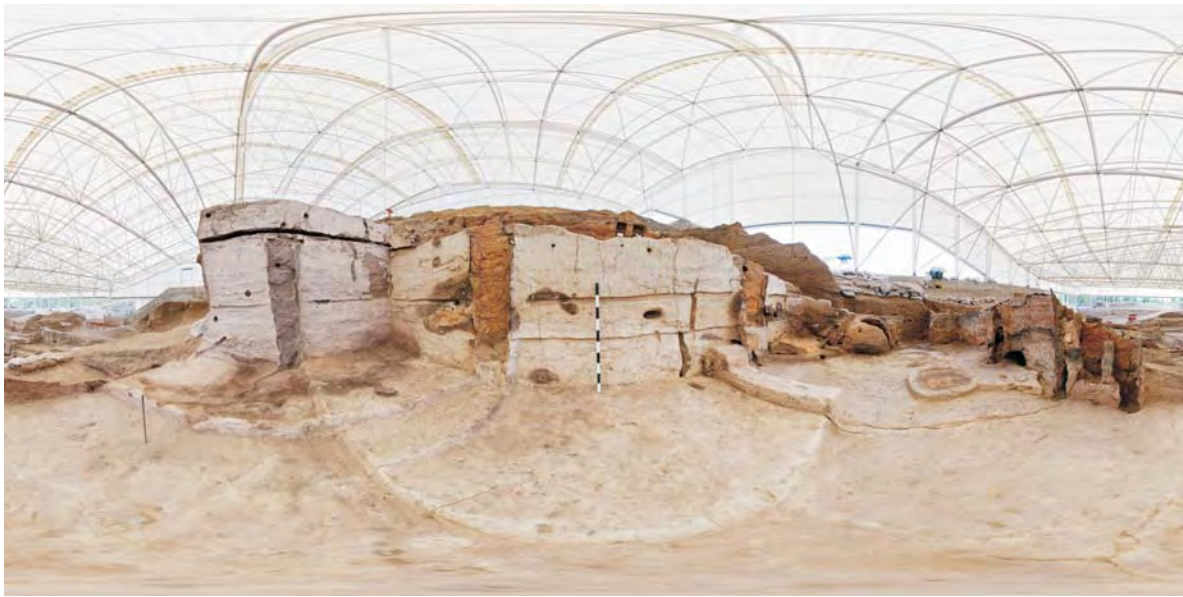
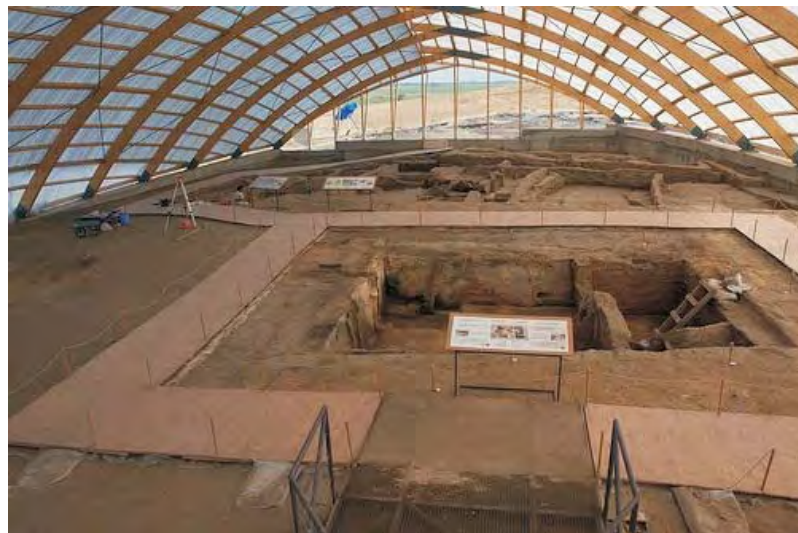
Pl. 11. Çatal Hüyük, Turkey. 1-3. Protection structures of the site, with infrastructure for visitors (after <http://www.catalhoyuk.com>).

A very good example of research, preservation and management of a *tell* settlement is the site of Çatal Hüyük (pl. 11/1-3), placed in Konya Plane, Turkey. Here we can find special shelters where visitors can look at vestiges preserved in situ even during researches, an experimental house (a reconstructed Neolithic house) and a visitor centre. On the website of the Çatal Hüyük research project² there is also an interesting management plan with a wide view on the archaeological site regarding issues as the conservation and protection of the site, integrated in a system of factors involved in this process. A special attention is given to real proposals for the preservation, protection and marketing of the site, on a short, medium and long term.
